A Red Light Running (RLR) Photo Enforcement System was installed at the intersection of IL 53 and Maple Avenue on August 3, 2009, after finding limited success with other attempted measures to promote safer driving and improve compliance with traffic laws. As a condition of use, both Illinois law and the Illinois Department of Transportation require periodic statistical analyses / evaluations be conducted.

## IL 53 & Maple Avenue Lisle, IL

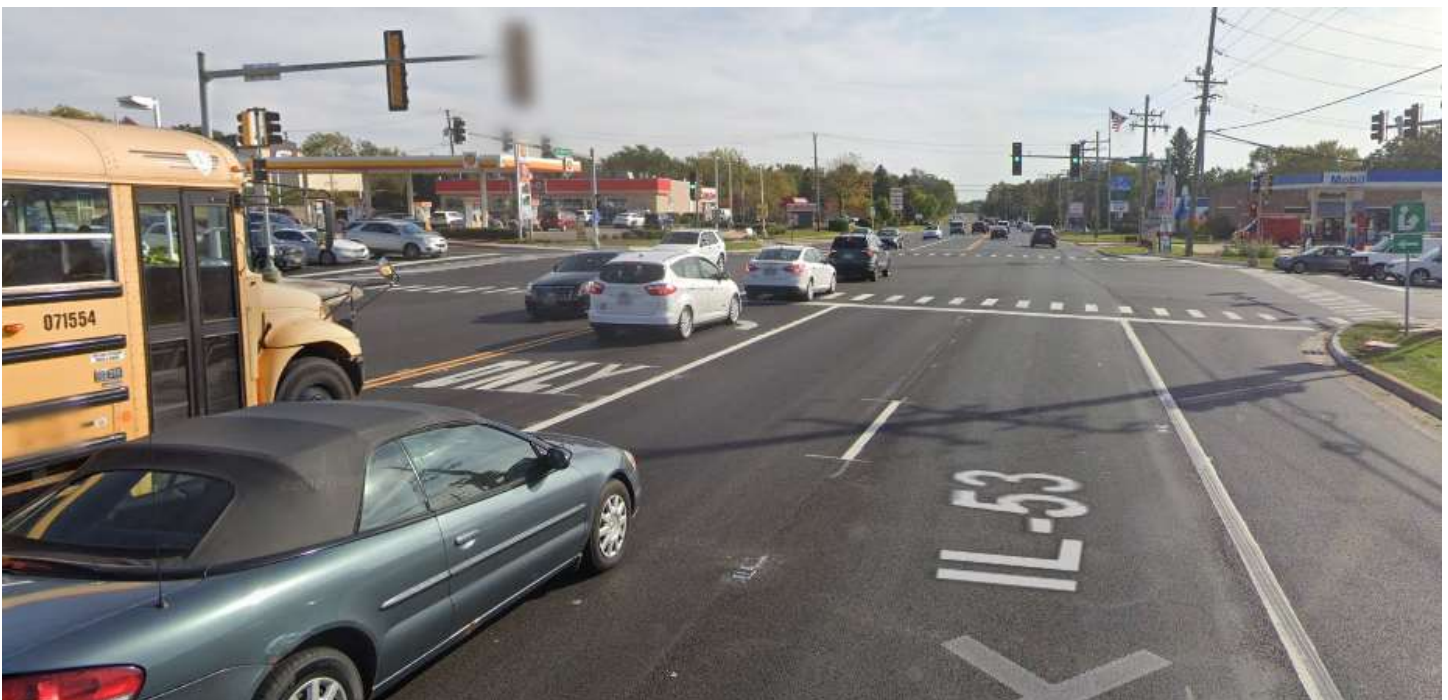
**IL 53 & Maple Ave. - Southbound Approach**

- RLR Photo Enforcement System monitors violations occurring on the southbound approach of the intersection
- RLR Photo Enforcement System installed: August 3, 2009
- Traffic signal timing strictly adheres to the guidelines for timing of clearances established by the Illinois Department of Transportation (IDOT), in accordance with the MUTCD standards. Neither the Vendor nor the Village has access to or influence over the establishment of signal timings. Both entities understand that tampering with these timings would be a safety violation with significant consequences.

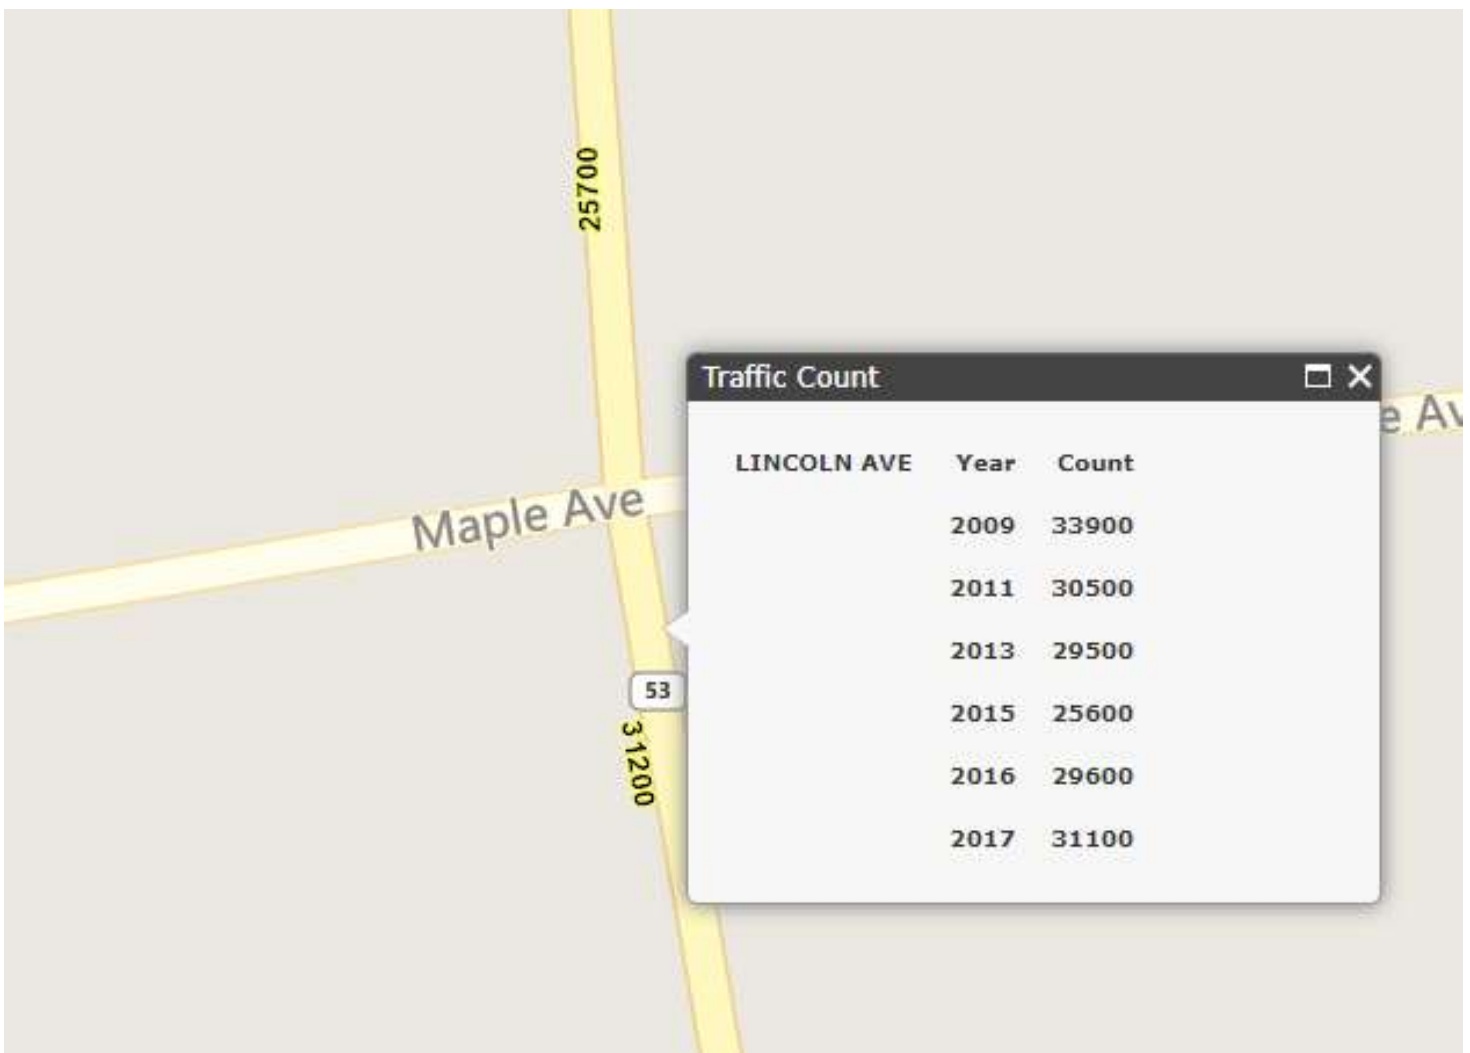
IL Rt. 53 & Maple Ave. (Northbound)

- 31,200 (2019)

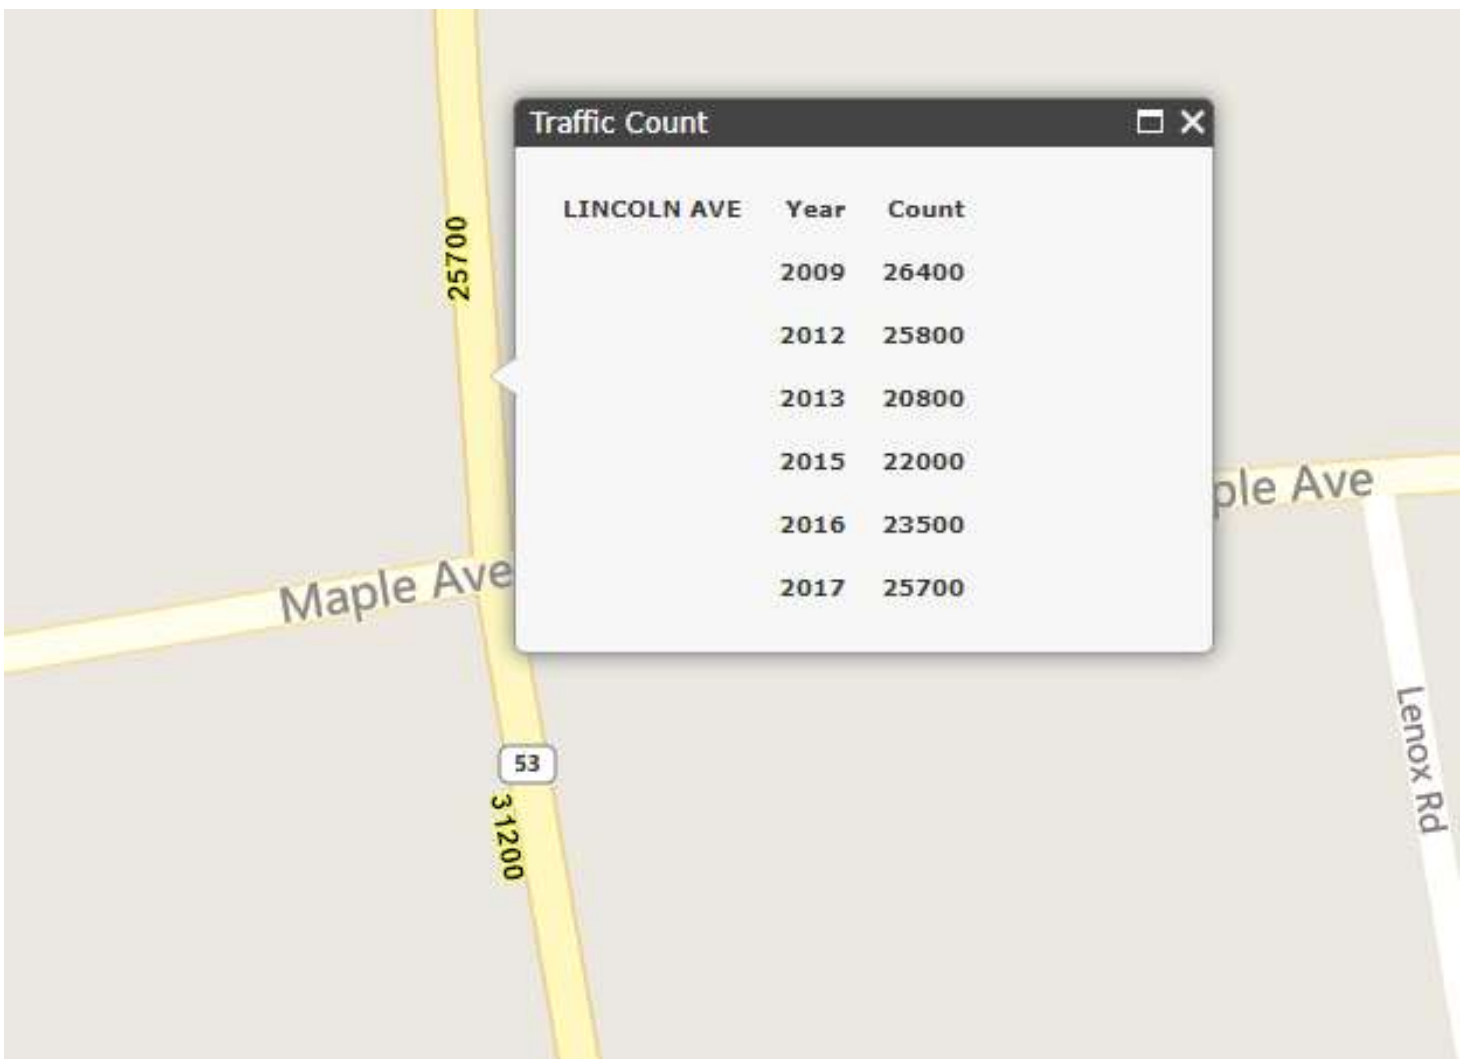
IL Rt. 53 & Maple Ave. (Southbound)

- 25,700 (2017)

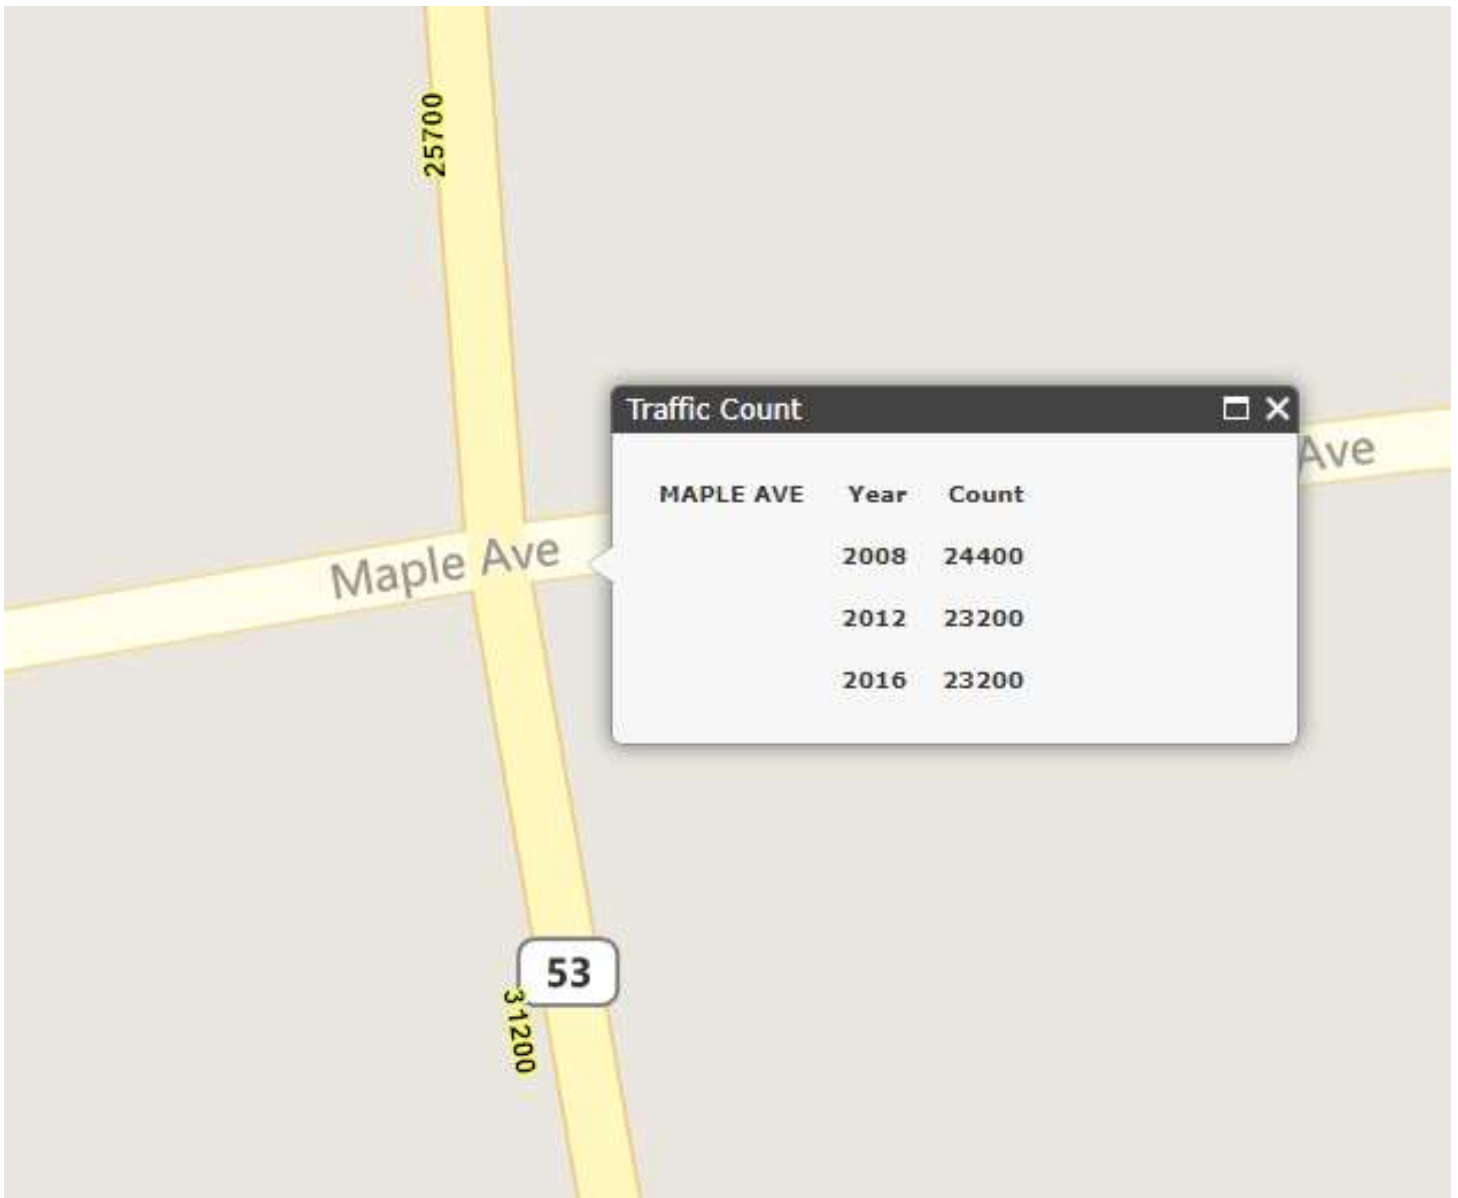
IL Rt. 53 & Maple Ave. (Eastbound/Westbound)

- 24,400 (2008)
- 23,200 (2012)
- 23,200 (2016)
